HAINES AREA STREAM CHANNEL TYPE SURVEY

Regional Information Report¹ No.1J89-04

Alaska Department of Fish and Game
Division of Commercial Southeast Region
Juneau, Alaska

January 1989

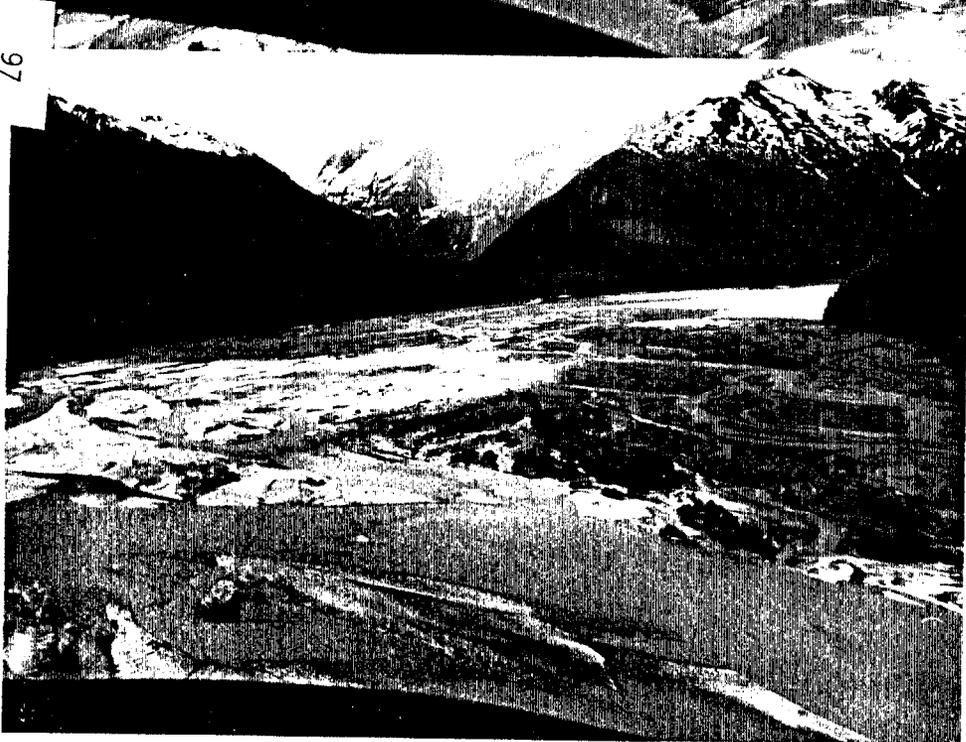
Lower end of Katzehin River

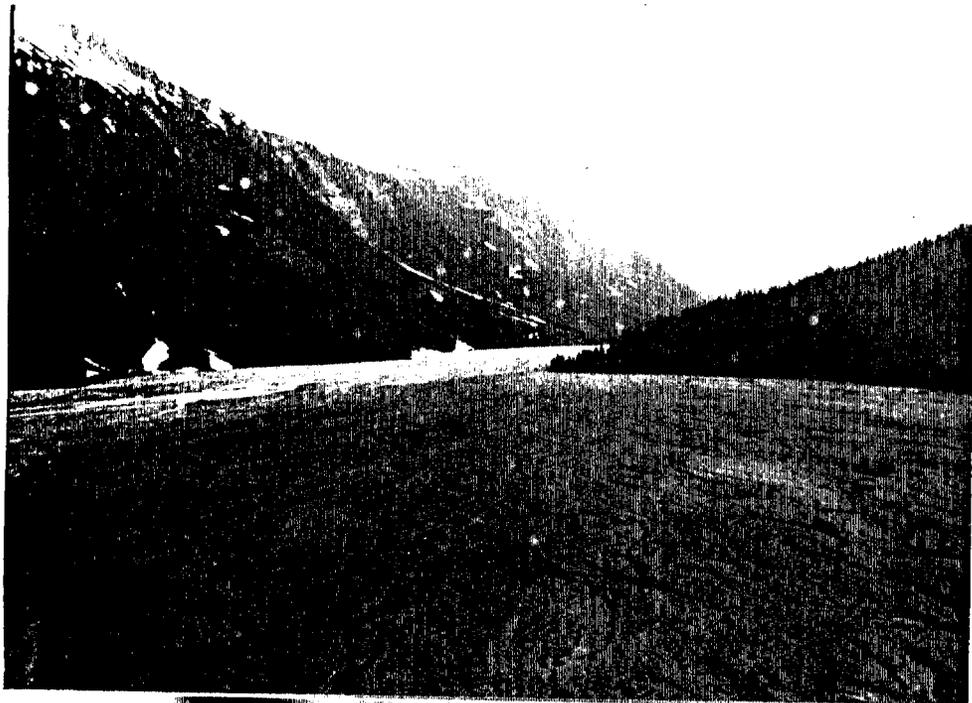
Upper end of Katzehin River

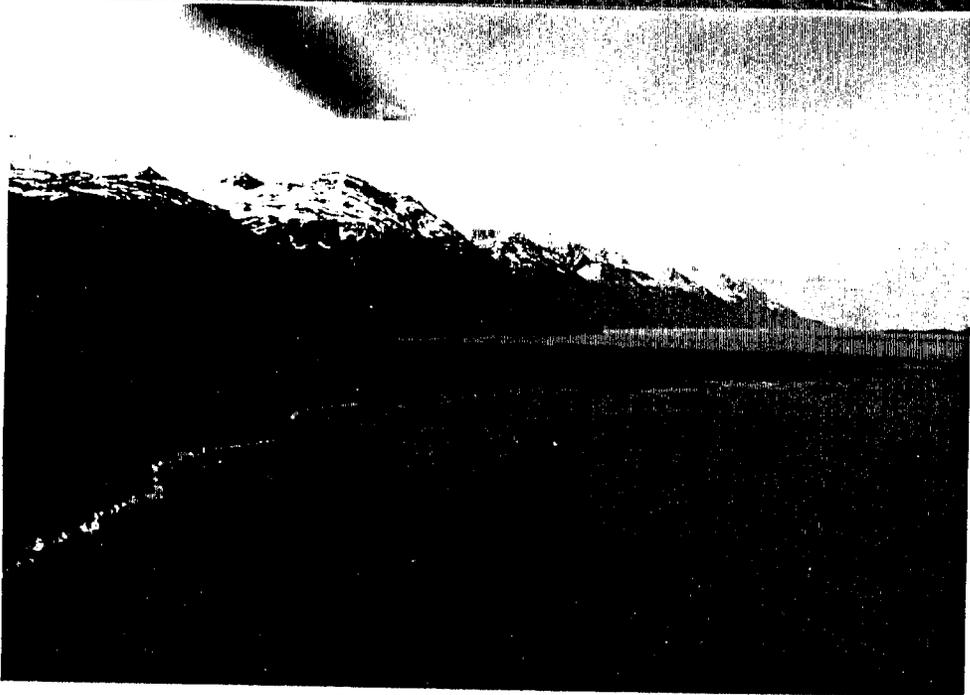
Tsirku River
(above Summit Creek)

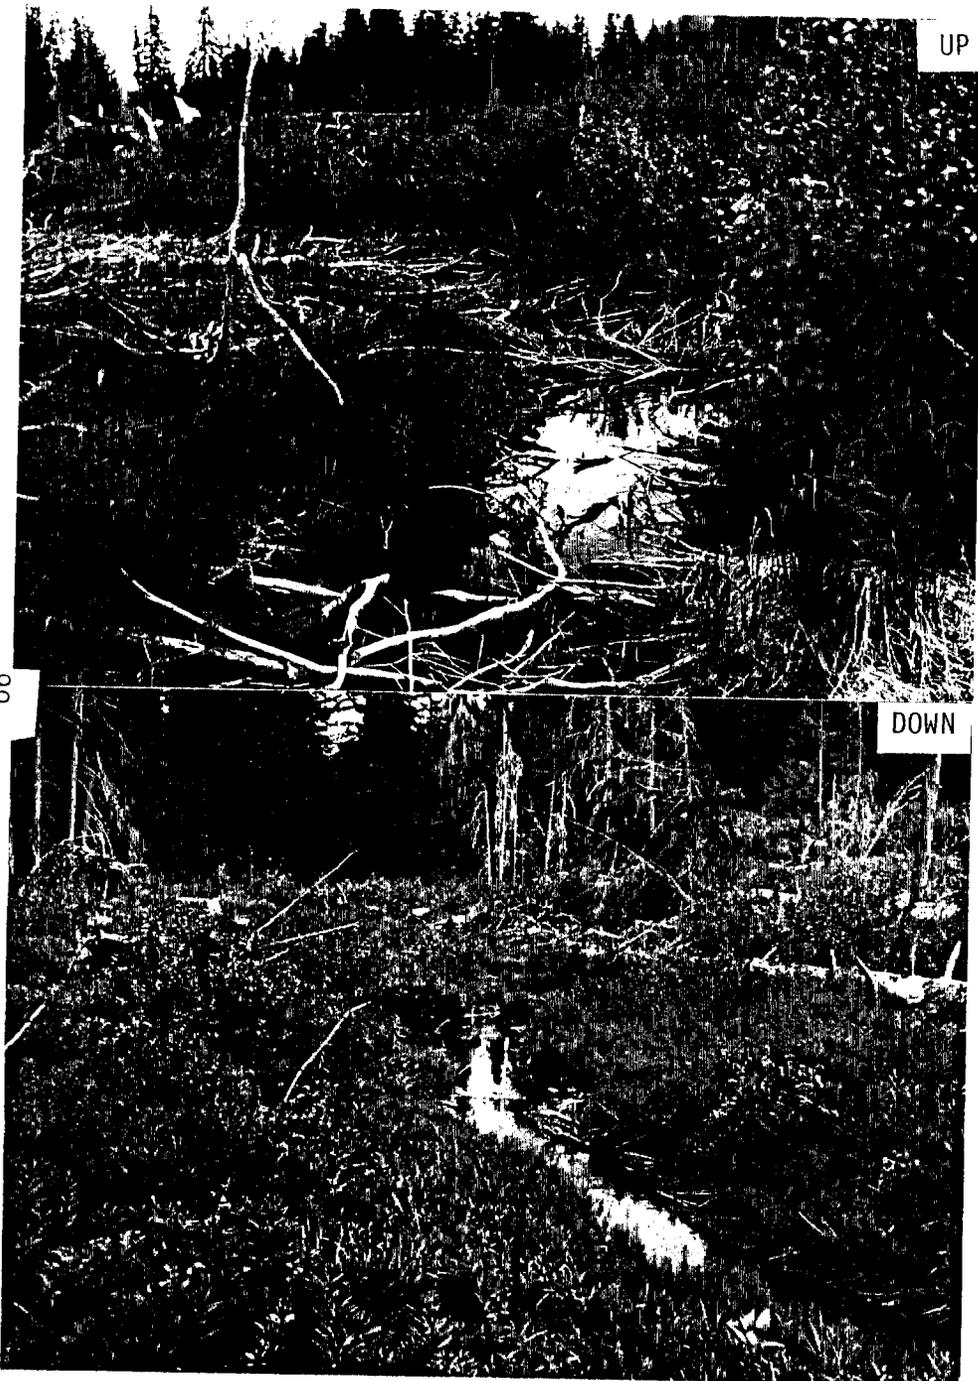
Katzehin River Delta

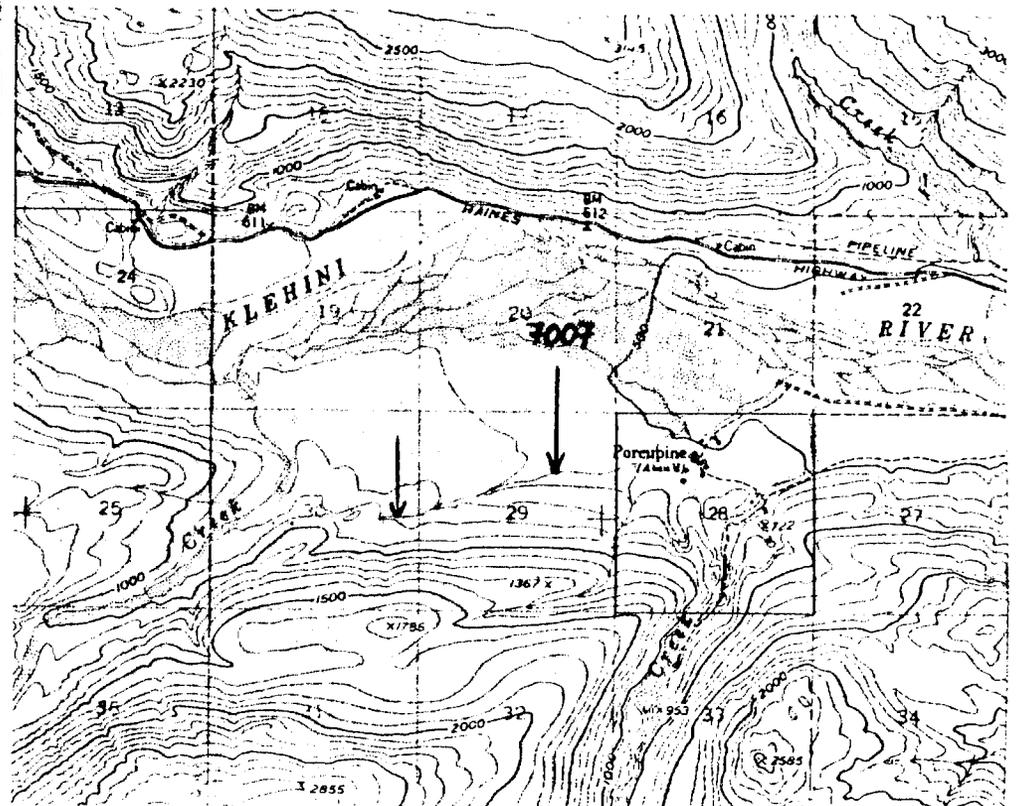
Taken in old clearcut above site #7007 on
115-32-10250-2017-3053.
Slash was left in stream in upper photo.
Arrow shows location of photos.

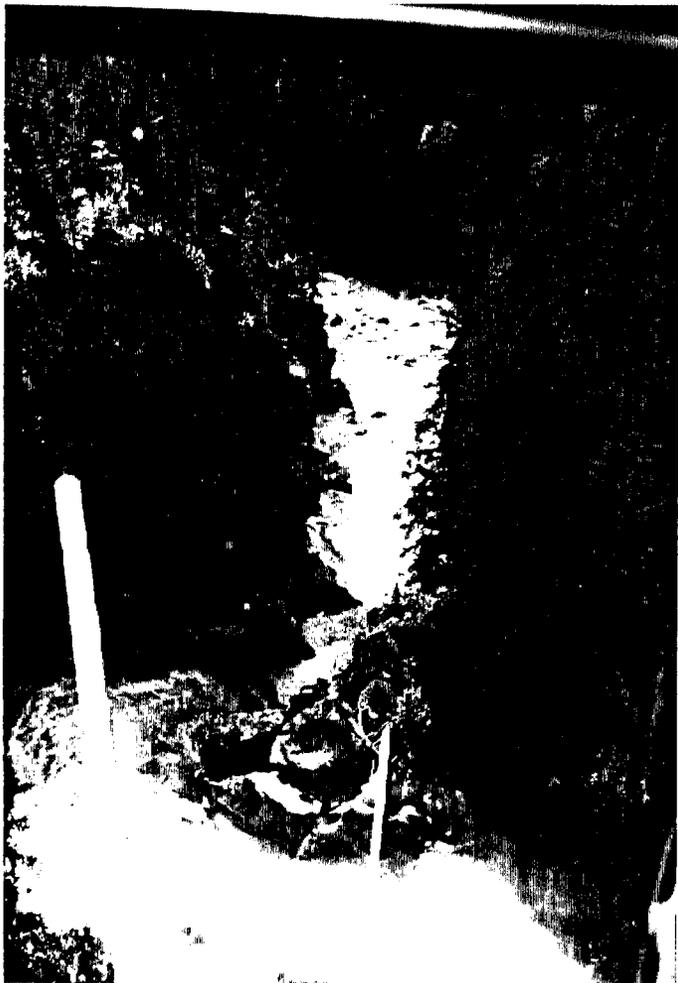
BELOW : Barrier falls on Skagway River.
See map for location.
